## **2015 WATER RESOURCES MANAGEMENT PRACTICUM REPORT**

# **Habitat Improvement in Agricultural Drainage Ditches in Wisconsin's Central Sands Region**

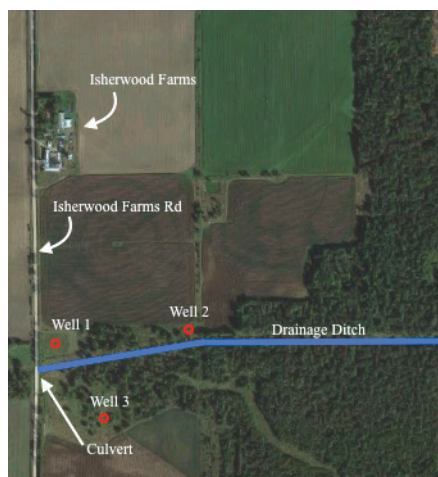
Figure 9: Aerial view of the Isherwood farm and well locations

two-inch diameter PVC pipe with 4.67-foot slotted PVC screens and installed 6.57, 6.37 and 6.06 feet below ground for wells 1, 2 and 3, respectively. Wells 1 and 2 are located on the north side of the Isherwood Lateral in primarily sandy soil. The south bank of the lateral, where well 3 is located, is comprised of much more humic soil (Figure 9). Water purged from well 3 was consistently darker and more tannic than that from wells 1 and 2.
