**Green Lake**  
**Aquatic Plant Community Assessment**  
Green Lake County, Wisconsin  
January 2015

Created by: Brenton Butterfield, Eddie Heath, Tim Hoyman, and Dan Cibulka  
Onterra, LLC  
De Pere, WI

Funded by: Green Lake Sanitary District  
Wisconsin Dept. of Natural Resources  
(ACEI-143-14)

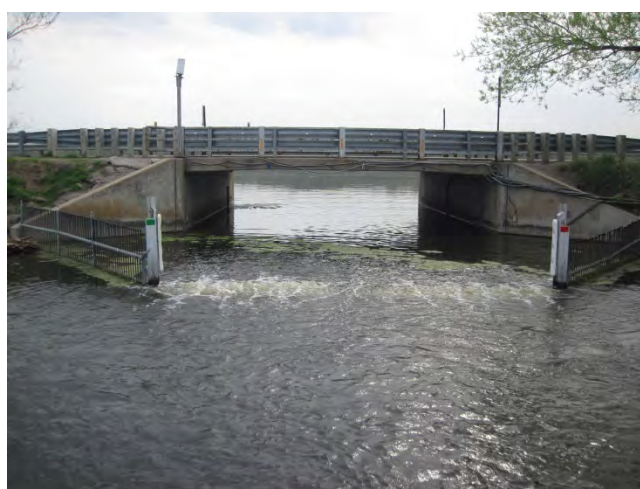
**Photo 3. Bubble barrier on Green Lake.**

The accidental introduction of the common carp (*Cyprinus carpio*) has likely also had adverse impacts to Green Lake's ecosystem. Direct foraging and uprooting of aquatic plants by common carp not only alters aquatic plant community structure, but they also resuspend bottom sediments and nutrients which increases turbidity and decreases water clarity (Fischer et al. 2013). Green Lake resource managers, recognizing the impact carp were having on Green Lake's ecosystem particularly within the estuaries where turbidity was high and aquatic vegetation was sparse, installed a "bubble barrier" underneath County

Highway A between Silver Creek Estuary and Green Lake (Photo 3). The seasonally operated bubble barrier appears to be an effective deterrent for carp that want to move into the Silver Creek Estuary from Green Lake. Aggressive commercial carp removal within the Silver Creek Estuary was also conducted to remove carp that were trapped within this upstream estuary. Aquatic plant surveys of the Silver Creek Estuary following the installation of the barrier indicated aquatic plant growth had increased greatly. A point-intercept survey within the Silver Creek Estuary in 2014 revealed 87% of the 203 sampling locations contained aquatic vegetation. A carp barrier was also installed between the County Highway K Marsh and Green Lake, but has not yet reached management objectives. Of the 94 sampling locations within the County Highway K Marsh in 2014, only 2 (2.1%) contained aquatic vegetation.

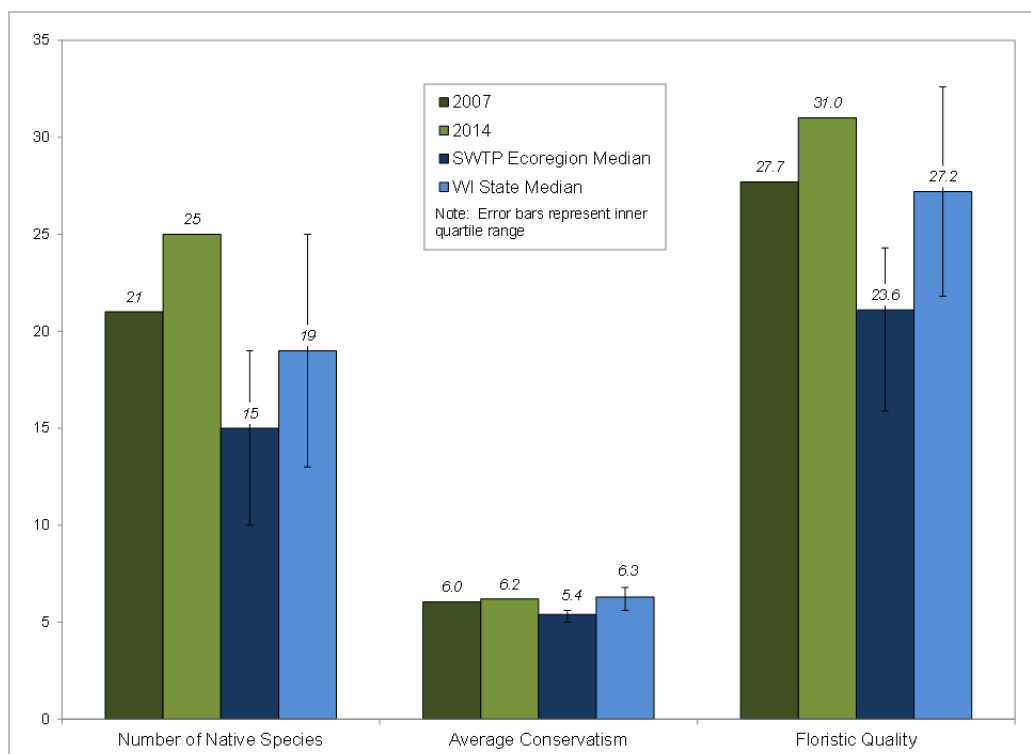
**Figure 8. Green Lake Floristic Quality Analysis.** Created using data from WDNR 2007 and Onterra 2014 point-intercept surveys. Regional and state medians created with Onterra and WDNR data. SWTP = Southeast Wisconsin Till Plains.

Figure 8 compares the FQI components of Green Lake from the 2007 and 2014 point-intercept surveys to median values of lakes within the Southeastern Wisconsin Till Plains (SWTP) ecoregion as well as the entire State of Wisconsin. Sasing 2013 reported that 34 native aquatic plant species were recorded on the rake during the WDNR 2007 point-intercept survey; however, this number included filamentous algae and aquatic moss which are not included in the FQI analysis. Additionally, this number included plants that were identified differently by different survey crews that were found to be the same species after the survey, and two species located in City Millpond in 2007 were not included because City Millpond was surveyed separately in 2014 from the Green Lake whole-lake point-intercept survey. In total, 21 native aquatic plant species were located on the rake in 2007 in Green Lake proper compared to 25 in 2014 (Figure 8). Both of these values exceed the median value for lakes within the SWTP ecoregion and for lakes throughout Wisconsin.

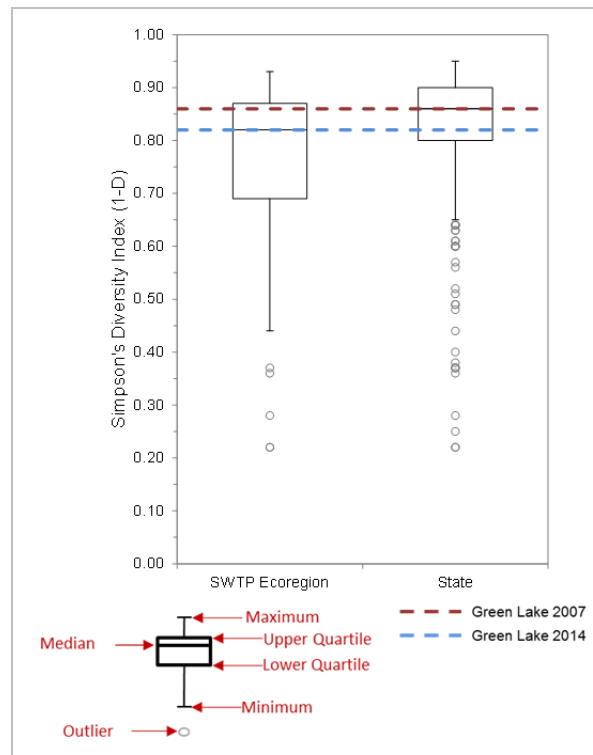
**Figure 9. Green Lake Simpson's Diversity Index.** Created using data from WDNR 2007 and Onterra 2014 point-intercept surveys. Ecoregion and state data created using Onterra and WDNR data.

Using the data collected from the 2007 and 2014 point-intercept surveys, Green Lake's aquatic plant community was shown to have Simpson's Diversity Index values of 0.86 and 0.82 in 2007 and 2014, respectively (Figure 9). In other words, if two individual aquatic plants were randomly sampled from Green Lake in 2014, there would be an 82% probability that they would be different species, compared to 86% in 2007. In 2007, the value of 0.86 fell above the median value for lakes in the SWTP ecoregion and was even with the median value for lakes state-wide. However, diversity decreased to the median ecoregional value of 0.82 in 2014 and fell below the state-wide median value. This decrease in diversity in 2014 can largely be attributed to the decline observed in the slender naiad population.

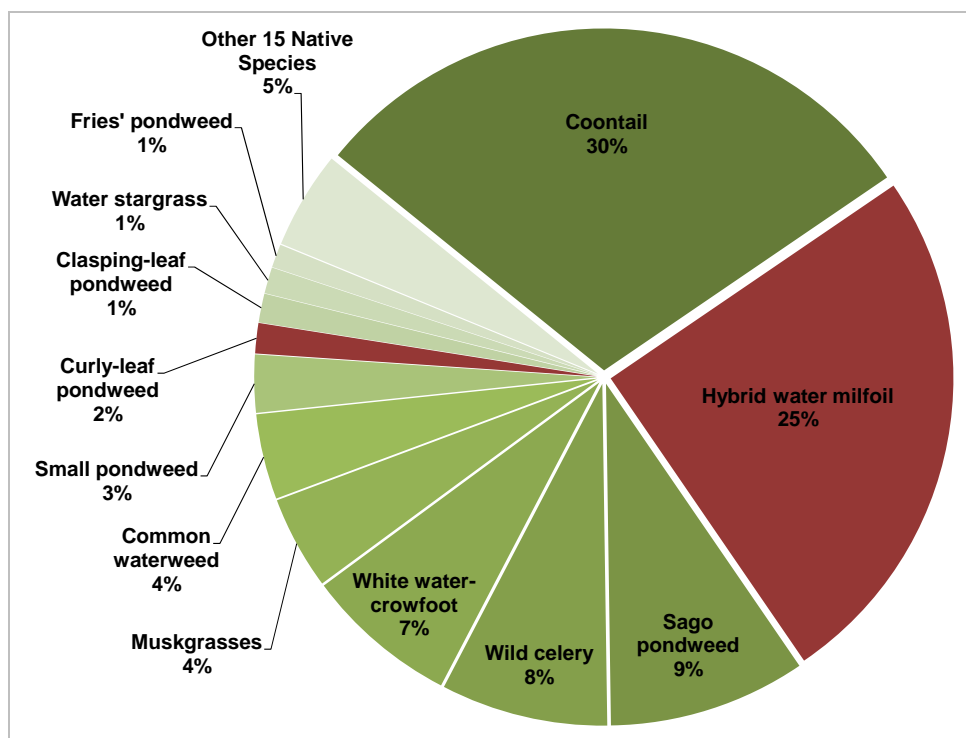
**Figure 10. Green Lake 2014 relative frequency of occurrence of aquatic plant species.** Created using data from Onterra 2014 point-intercept survey.

As explained earlier, the littoral frequency of occurrence analysis allows for an understanding of how often each of the plants is located during the point-intercept survey. Because each sampling location may contain numerous plant species, relative frequency of occurrence is one tool to evaluate how often each plant species is found in relation to all other species found (composition of population). For instance, while coontail was found at approximately 48% of the littoral sampling locations in Green Lake in 2014, its relative frequency of occurrence is 30%. Explained another way, if 100 plants were randomly sampled from Green Lake, 30 of them would be coontail, 25 hybrid water milfoil, etc. Figure 10 displays the relative occurrence of aquatic plant species from Green Lake in 2014, and illustrates that 55% of the community is comprised of just two species: coontail and hybrid water milfoil. This dominance of the community by two species yields the lower species diversity.

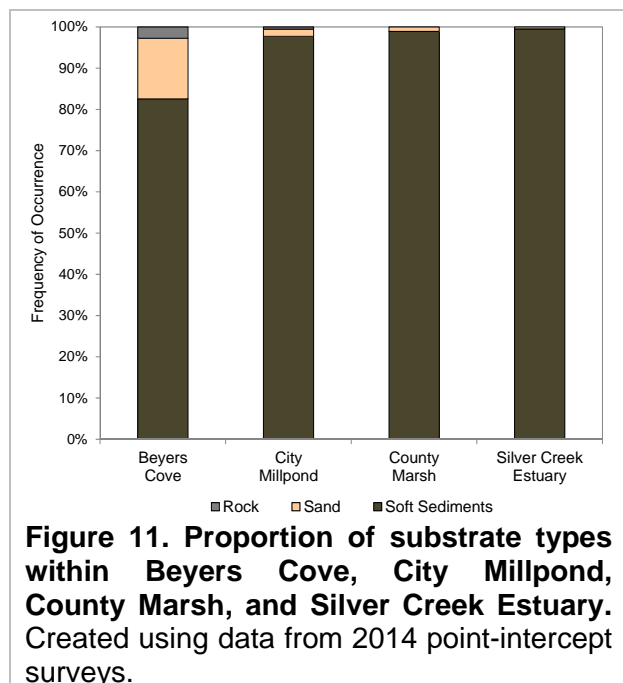
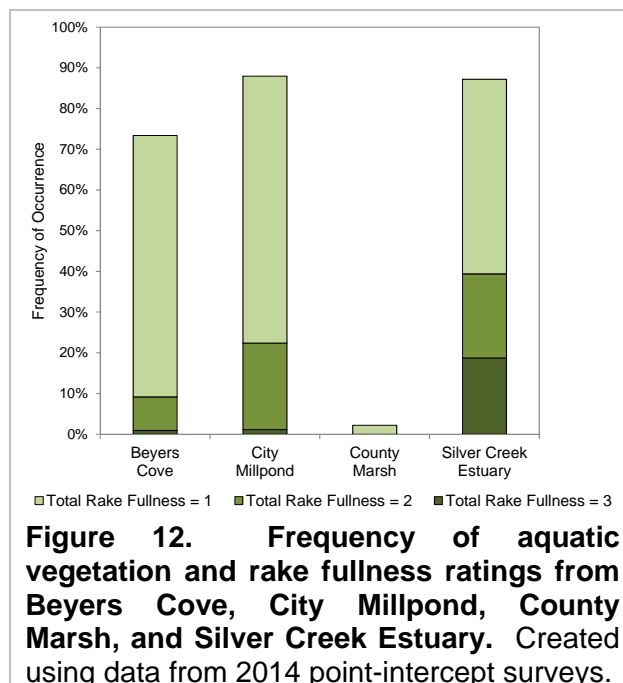
City Millpond contained the highest number of aquatic plant species, followed by Silver Creek Estuary, Beyers Cove, and County Marsh, respectively. Sediment data collected during the point-intercept surveys indicated that the majority of these basins contain soft sediments (muck), while only small portions of comprised of sand and/or rock (Figures 11 and Figures 13-16). Approximately 70-90% of the point-intercept sampling locations in Beyers Cove, City Millpond, and Silver Creek contained aquatic vegetation, while only 2% contained aquatic vegetation in County Marsh (Figure 12 and Figures 13-16).

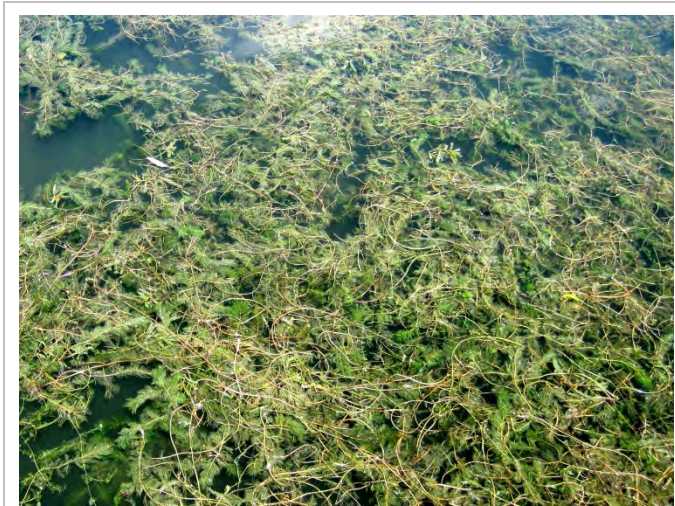
**Photo 4. Hybrid water milfoil (*Myriophyllum sibiricum X spicatum*) in Beyers Cove, Green Lake.** Photo taken on June 18, 2013.

Eurasian water milfoil (EWM) was first documented in Green Lake in 1969. In 2010, DNA analysis revealed that the plants in Green Lake were hybrid water milfoil (HWM), a cross between EWM and the indigenous northern water milfoil. Onterra ecologists sent in additional milfoil samples in 2013, and these were also confirmed as HWM (Photo 4). This report only discusses the HWM population within Green Lake proper, and information regarding the HWM populations and control strategies implemented in 2014 within the estuaries can be found in the Green Lake 2014 Letter Report.

While more extensive and detailed mapping surveys of HWM were completed on the three basins previously mentioned, the 2014 whole-lake point-intercept survey was used to collect information regarding the HWM in Green Lake. The point-intercept survey allows for a determination of HWM abundance within the lake and a relatively coarse picture of where it's located. As discussed in the previous section, HWM was the second-most frequently encountered aquatic plant in Green Lake with a littoral frequency of occurrence of 42%. Statistical analysis revealed that its occurrence in 2014 was not statistically different from its occurrence in 2007. Hybrid water milfoil has likely been a highly dominant plant within the lake for some time, as M.J. Bumby noted its high abundance in 1971. The 2014 point-intercept survey found that HWM grows throughout littoral areas in Green Lake, and the densest areas can be found along the northern portion of the lake (Figure 17 and Map 12). HWM was most abundant between 5 and 14 feet of water in 2014, and is similar to what was found in 2007.

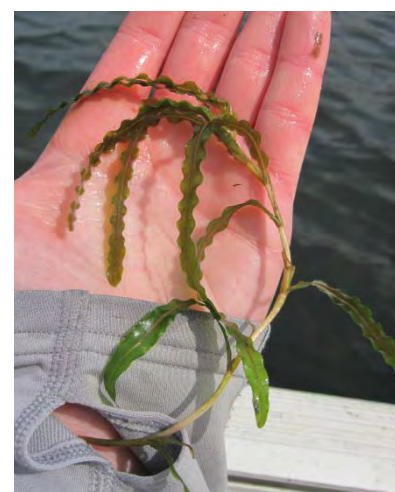
**Photo 5. Curly-leaf pondweed (*Potamogeton crispus*) in City Millpond, Green Lake.** Photo taken on May 14, 2014.

Curly-leaf pondweed (CLP) was first discovered in Green Lake in 1971 (Photo 5). To accurately assess a lake's CLP population, surveys need to be conducted in late spring or early summer when these plants are at or near their peak growth. However, the point-intercept survey on Green Lake proper in 2014 was conducted in July, likely after most of the plants had naturally senesced. For this reason, the full extent of the CLP population in Green Lake is not known.

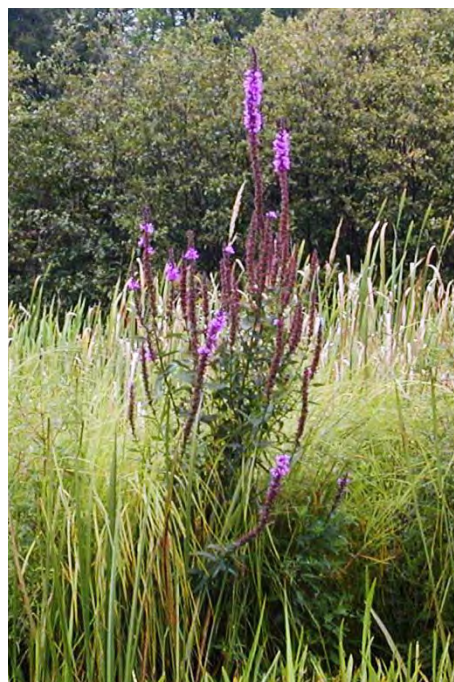
**Photo 6. Purple loosestrife (*Lythrum salicaria*) on a northern Wisconsin Lake.**

Purple loosestrife is a perennial herbaceous plant native to Europe and was likely brought over to North America as a garden ornamental. This plant escaped from its garden landscape into wetland environments where it is able to out-compete our native plants for space and resources. First detected in Wisconsin in the 1930's, it has now spread to 70 of the state's 72 counties. Purple loosestrife largely spreads by seed, but also can vegetatively spread from root or stem fragments.

Isolated, scattered populations of purple loosestrife were located along the shorelines of City Millpond, Silver Creek Estuary, and County Marsh in 2013 and 2014 (Maps 4-7). There are a number of effective control strategies for combating this aggressive plant, including herbicide application, biological control by non-native beetles, and manual hand removal. At this time, hand removal by volunteers is likely the best option as it would decrease costs significantly. Additional purple loosestrife monitoring would be required to ensure the removal of the plant from the shorelines within these areas.

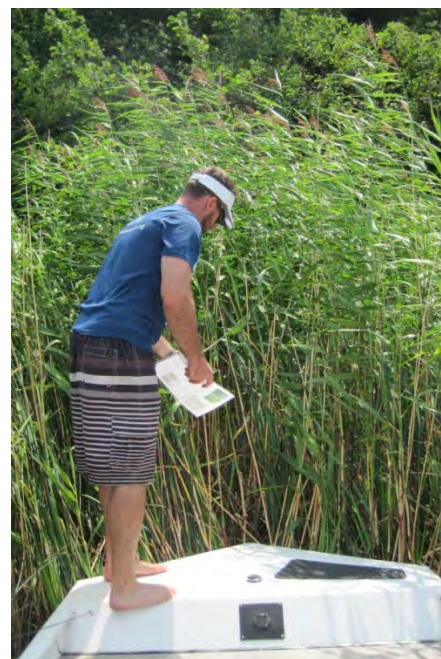
**Photo 7. Giant Reed (*Phragmites australis* subsp. *americanus*) on a northern Wisconsin Lake.**

Giant reed (*Phragmites australis* subsp. *americanus*) is a tall, perennial grass found in wetlands and in shallow water throughout Wisconsin (Photo 7). While a non-native strain (*P. australis* subsp. *australis*) of this species exists in Wisconsin, the plants located along the shorelines of Silver Creek Estuary and County Marsh were identified by the UW-Stevens Point Herbarium as the native strain, subspecies *americanus* (Map 10 and 11).

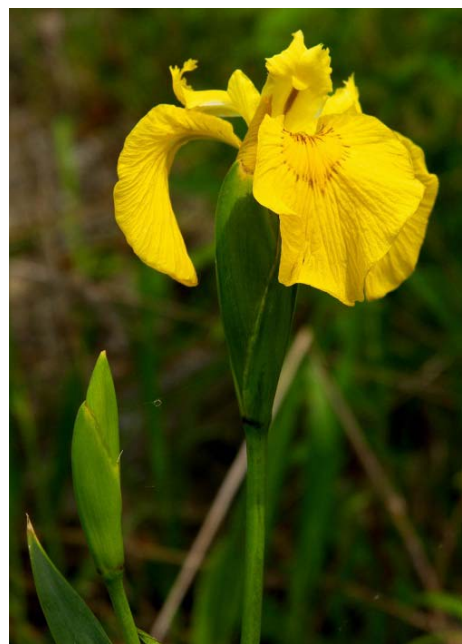
**Photo 8. Pale-yellow iris (*Iris pseudacorus*).**

One occurrence of pale-yellow iris (*Iris pseudacorus*) was located growing on the shoreline Silver Creek Estuary (Map 11). Pale-yellow iris is a large, showy iris with bright yellow flowers. Native to Europe and Asia, this species was sold commercially in the United States for ornamental use and has since escaped into Wisconsin's wetland areas forming large monotypic colonies and displacing valuable native wetland species (Photo 8). At the time of this report, it appears that the only means of control are continual hand removal and monitoring.

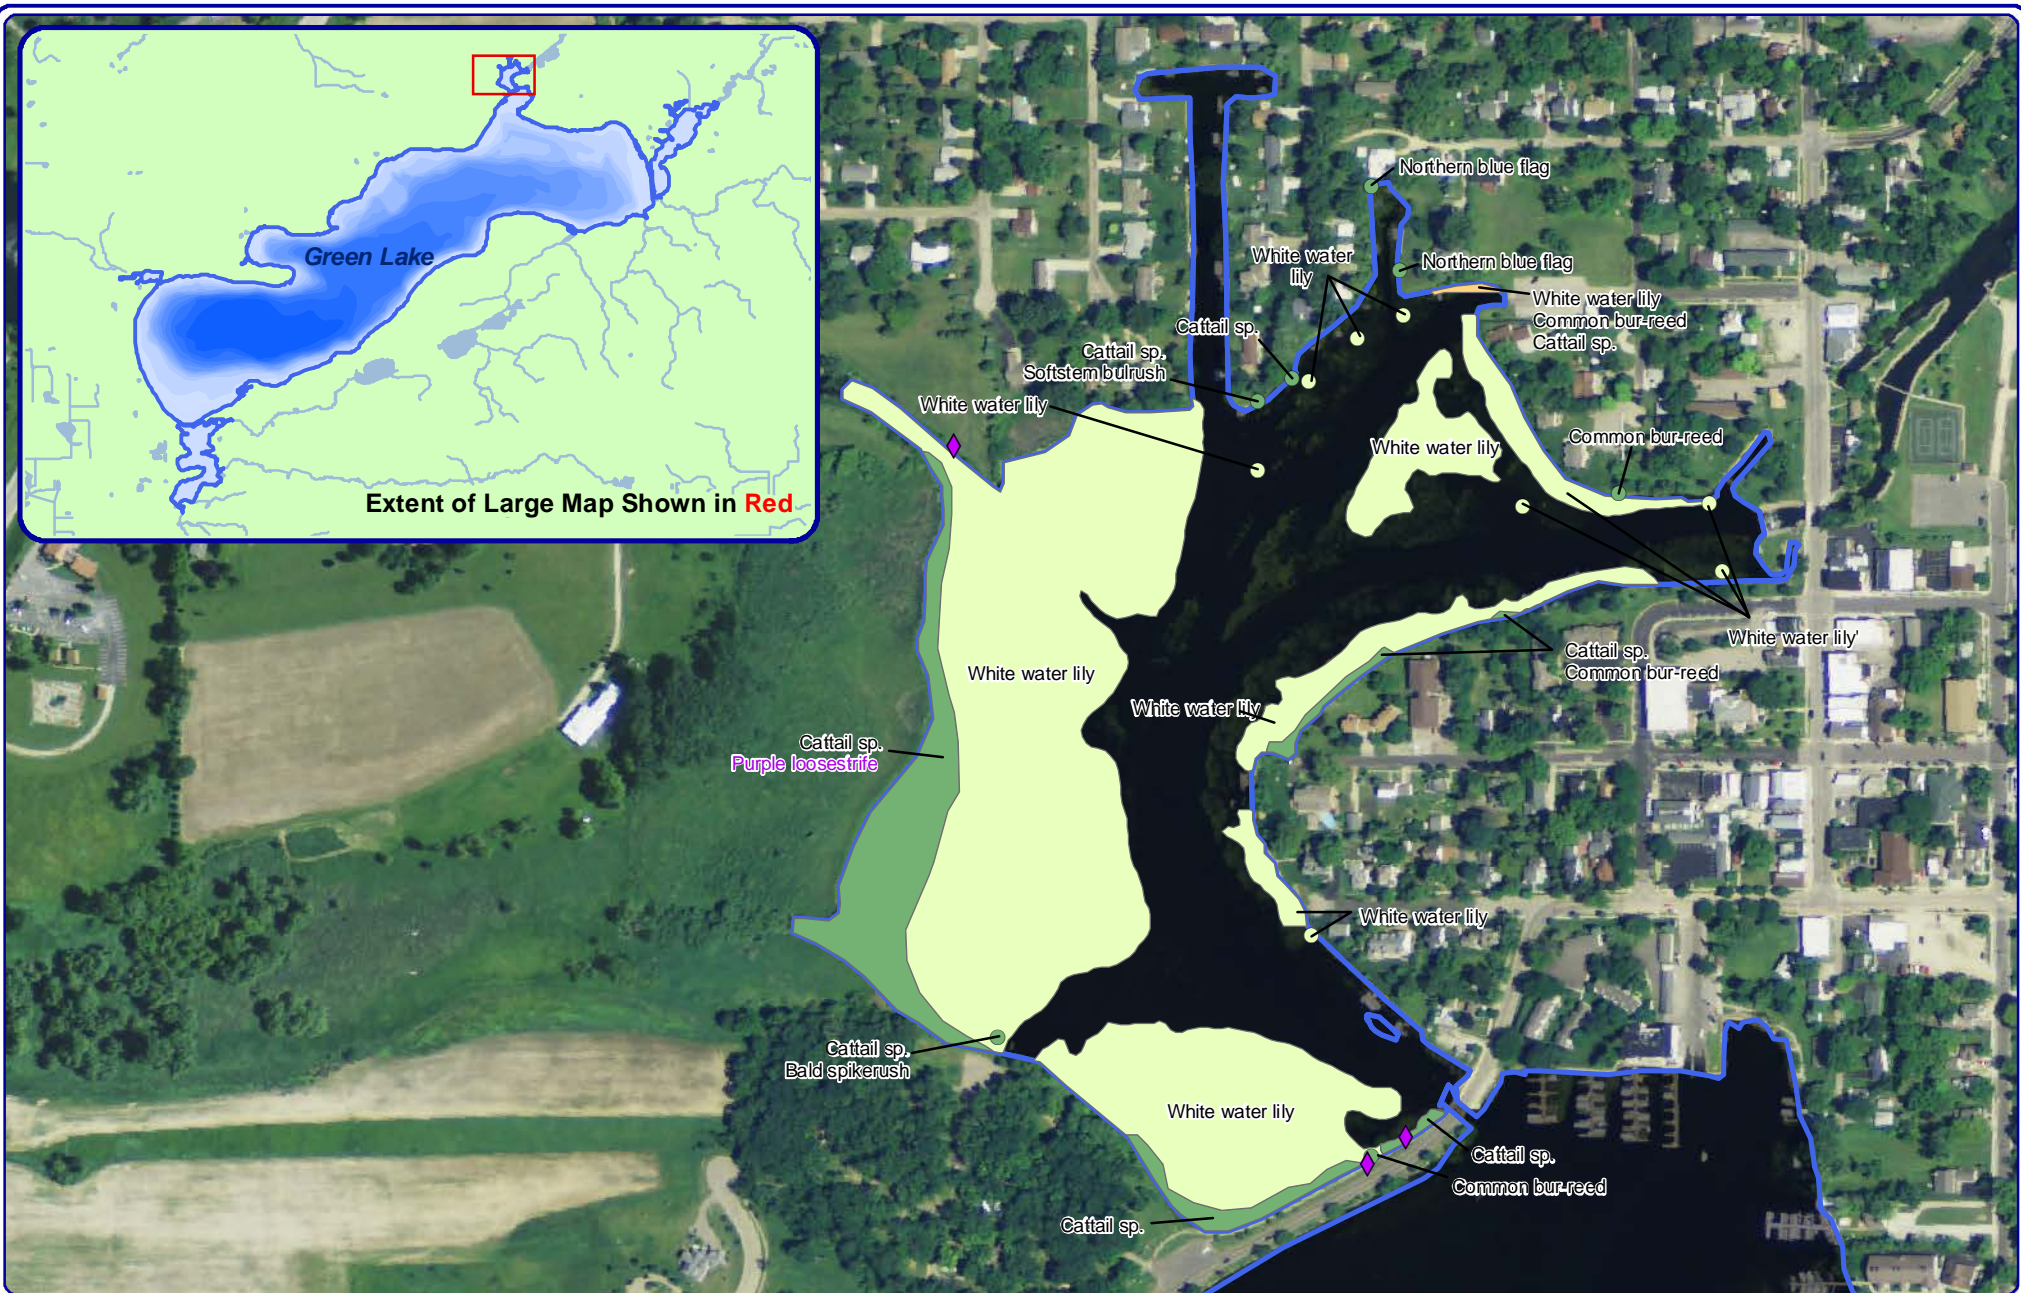
Green Lake - Beyers Cove  
 Green Lake County, Wisconsin

**2013 Emergent & Floating-Leaf  
 Aquatic Plant Communities**

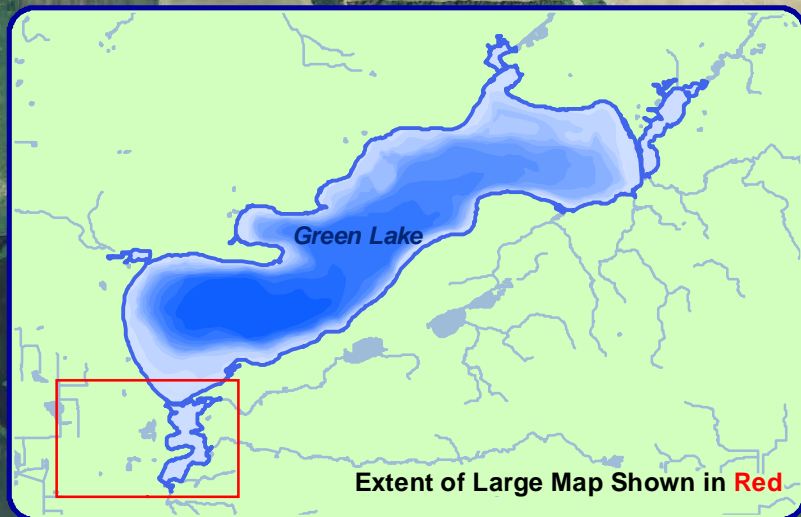
Map 10  
Green Lake - Silver Creek Estuary  
Green Lake County, Wisconsin  
**2013 Emergent & Floating-Leaf  
Aquatic Plant Communities**
