Addressing Impairment in Beaver Dam Lake and Beaver Creek

WATER RESOURCES
MANAGEMENT PRACTICUM REPORT 2017

NELSON INSTITUTE FOR ENVIRONMENTAL STUDIES
UNIVERSITY OF WISCONSIN-MADISON

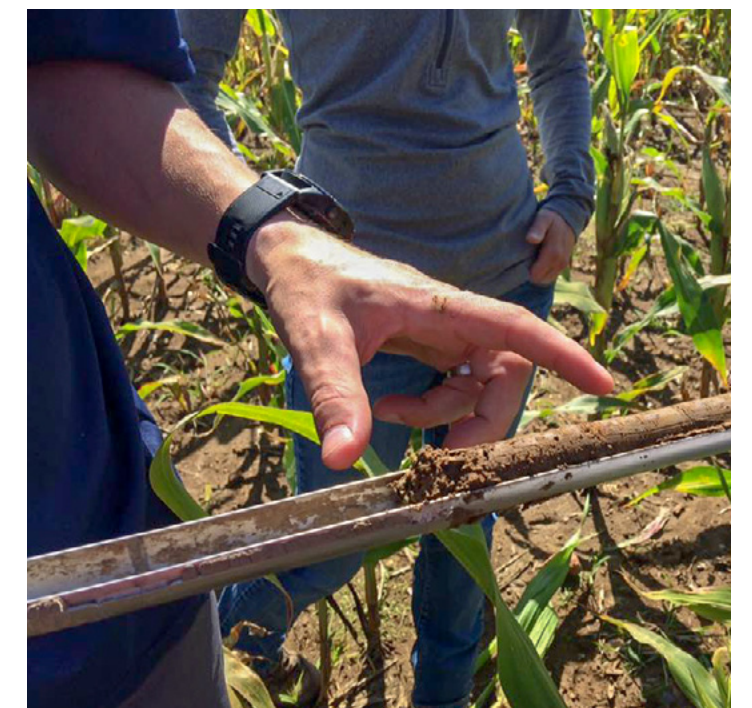
Figure 11: Bray-1 P in soil samples.

Figure 11 shows the soil test P levels (ppm) from each of the samples. Lines across the bars show the crop-optimal P (ppm) as identified by UW-Extension (Laboski and Peters, 2012). With the exception of sample #7, soils at all locations had Bray-1 P levels above or far above crop-optimal levels, meaning that soil P levels are in excess of nutrient recom-

mendations. Note that only sample 7 was lower than optimal. Samples 4 – 7 were from the same area of the field, indicating variability in nutrient levels within the same field. The number of soil samples did not allow for statistical comparisons and are not representative of the entire subwatershed.

The soil sampling we conducted provides some insight into the agronomic needs and current condition of the soil in a small portion of the watershed. The above crop-optimal levels may be a result of historic agricultural practices including long-term manure application. Further soil sampling and data analysis can help quantify the potential for nutrient pollution from the land. Models (e.g., Pote et al., 1995; Vadas et al., 2004) could be used to estimate the amount of dissolved P that would be present in runoff based on soil Bray-1 P. More detailed watershed scale modeling, for example with the Soil and Water Assessment Tool (SWAT), can build on our results and help identify sediment and nutrient delivery to Beaver Creek. Soil sampling results can also be used with further field-scale modeling, such as SnapPlus, to assist producers with nutrient management planning on their fields. SnapPlus is a viable option that supports protecting water quality while allowing the producer to plan for optimal crop yields.

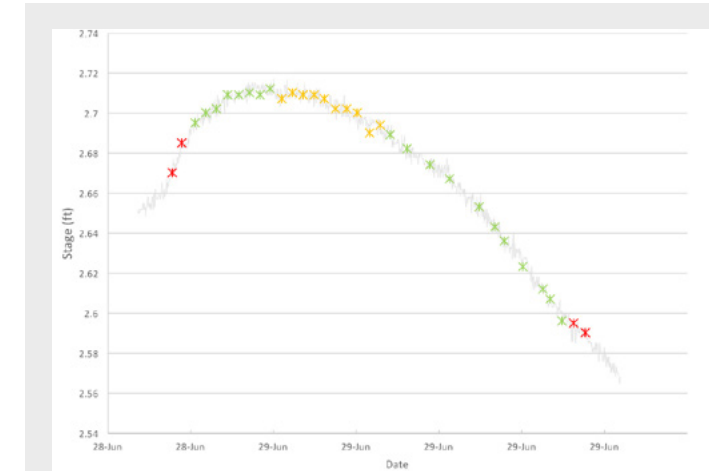
Figure 14: Storm 1 hydrograph with the composite water samples color-coded to show the different stages captured.

The ISCO sampler was programmed to record flow depth and calculated flow volume every two minutes. Flow during a preliminary storm was measured to guide programming of the ISCO so that volume based samples were spread over the entire hydrograph. Volume intervals were changed for each storm based on the amount of rain predicted and the pre-storm stage height of the stream. Samples were composited for analysis. Generally, five composites were created to represent the start, the rising limb, the peak, the falling limb, and the end of the hydrograph (Figure 14).

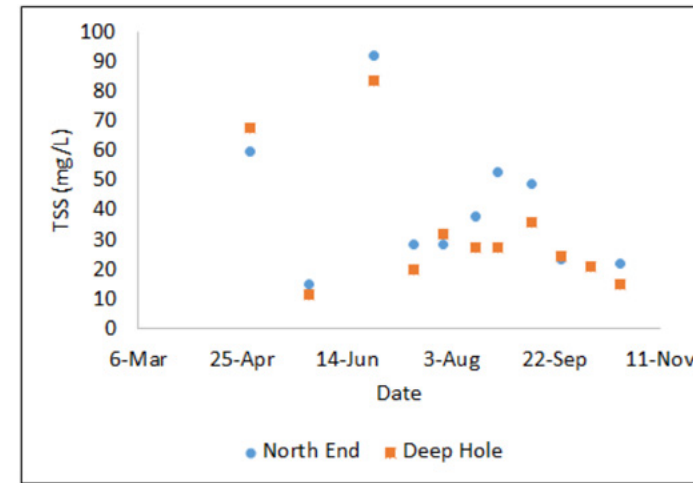
Figure 57: Total suspended solids (mg/L) over 2017 as measured by WRM.

Total suspended solids (TSS) correlates closely between both sampling locations. The most significant finding was the sudden spike in early July to between 80-90 mg/L (Figure 57).
